## SAS Superstructure

### Daily Diary Report by Bid Item

Diary #: 830 Const Calendar Day: 322 Date: 22-Apr-2013 Monday

04-0120F4  
04-SF-80-13.2/13.9  
Self-Anchored  
Suspension Bridge

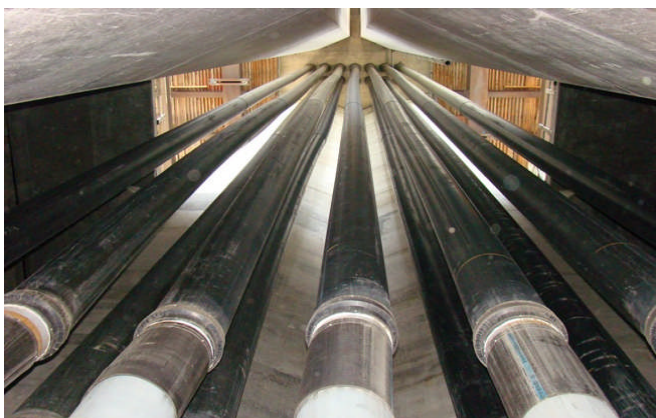
Cable tie down HDPE pipes that are no longer plumb due to the slipping of the upper dresser coupling connection which is failing.

- Performed miscellaneous informal inspections around the jobsite today. The connection of the upper dresser couplers for the W2 cable tie-downs was inspected. See photos below for more details of the findings for this inspection. Wrote an email to pertinent Caltrans and TY-Lin personnel expressing my concerns over these findings and to add this item to the W2 punchlist. It is my opinion that this issue needs to be resolved/fixed sooner rather than later.

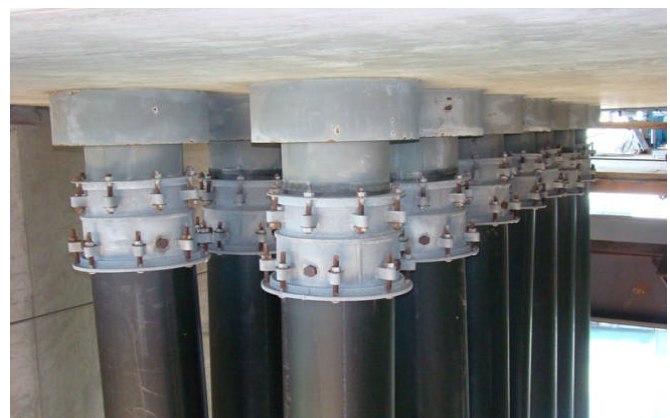
Cable tie down upper dresser couplers seen slipping down the bottom section of the steel pipe blockout stub.

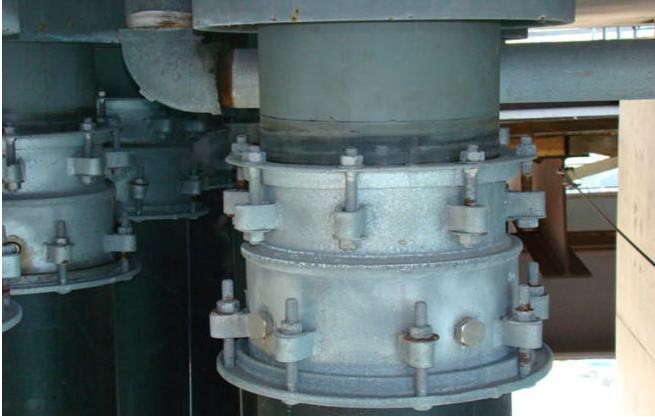
Closeup of the cable tie down upper dresser couplers slipping, notice the top black mark placed by SDI ironworkers in the fall of 2009.

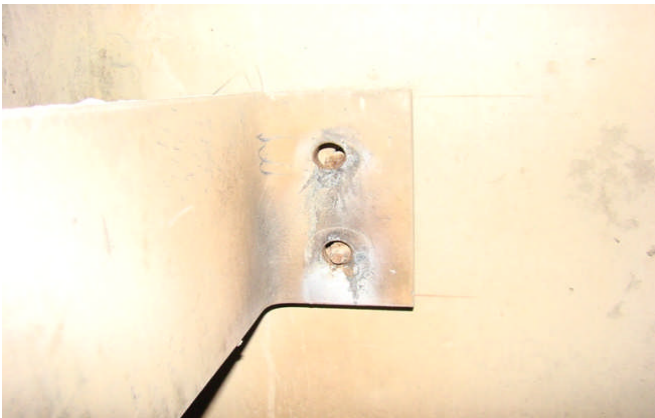
Bolts need to be replaced for the W2 retaining wall ladders at both column casings.

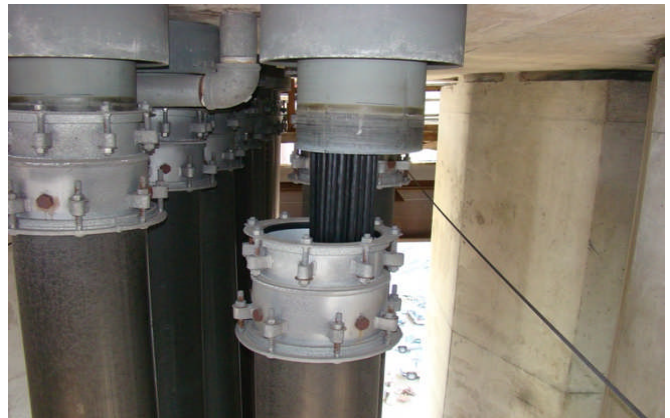
Failed upper dresser coupler connection for the cable tie down HDPE pipes along the E-Line on the far north east tendon looking west.

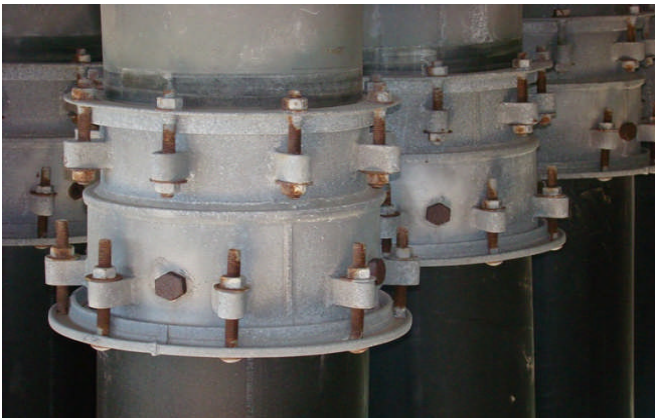
Closeup of the cable tie down upper dresser couplers slipping down the steel bottom pipe blockout stub, notice the skid marks on the steel.

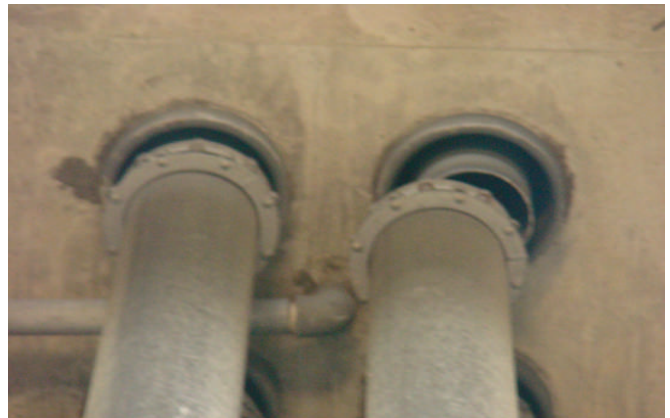
Failed connection of the upper dresser coupler rubber gasket friction connection.

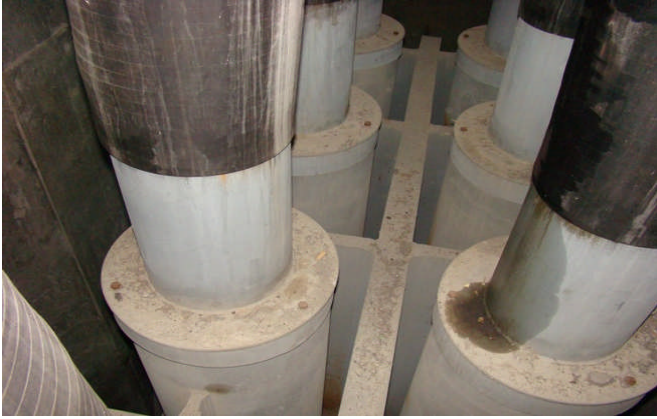
Bottom connection of the cable tie down exterior corrosion protection system which appears to be keeping water out.

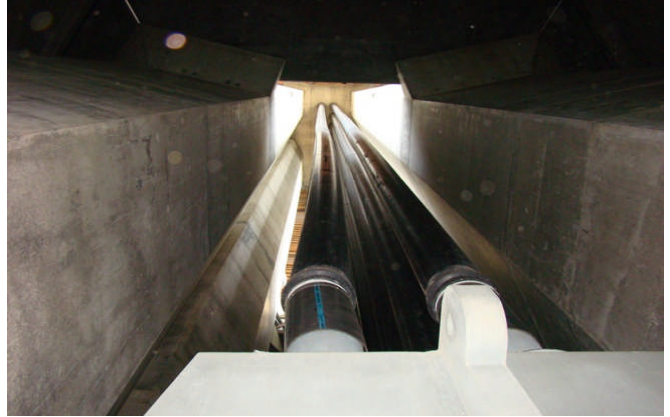
Cable tie down HDPE pipes that are no longer plumb due to the slipping of the upper dresser coupling connection which is failing.
